2 ANALYSIS AND ASSESSMENTS

2.1 Facilities Needs/Issues/Concerns

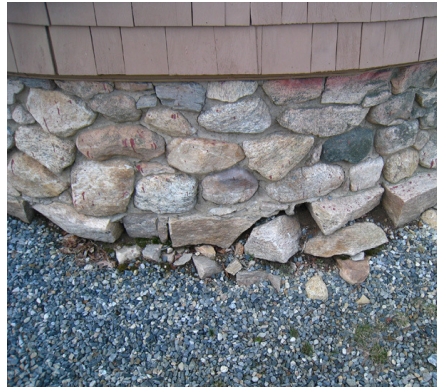
- Open joints and loose stones at foundation wall below 1893 portion of building and exposed waterproofing membrane laid over foundation at north turret
- Peeling paint at wall shingles at junction between west office wing extension roof and adjacent building wall, likely due to standing snow on roof
- Rusting of roof level vents, west elevation
- Peeling paint at exterior ramp and stair railings

Loose foundation stones at north elevation

- Repoint the foundation wall and excavating the earth adjacent to the north turret to allow for the installation of sub-surface waterproofing
- Install snow melting heat cables where the west office wing extension abuts the building wall to prevent damage to wall
- Prepare and paint metal elements (roof vents and stair rail) to prevent further deterioration

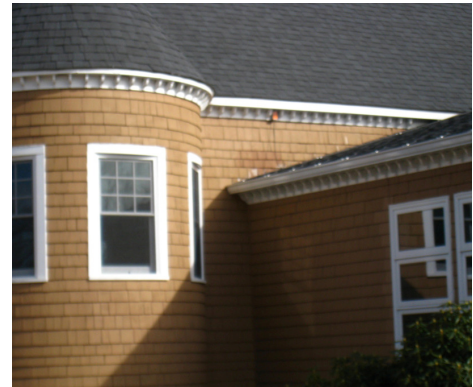
peeling paint at junction between building wall and roof, west elevation

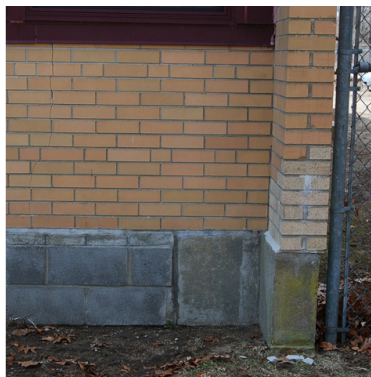
- Displaced brick at northeast corner of 1959 classroom wing
- Cracked and previously patched cast stone decorative elements at south elevation of auditorium and severe efflorescence at the brick below the patched areas

Displaced brick at northeast corner of 1959 classroom wing

- Rebuild area of displaced brick at northeast corner of 1959 classroom wing
- Remove deteriorated patches at cast stone decorative elements and window sills and repatch. Repair cracked original elements with patching material and stainless steel pins if required. Clean efflorescence from brick below previous patched areas

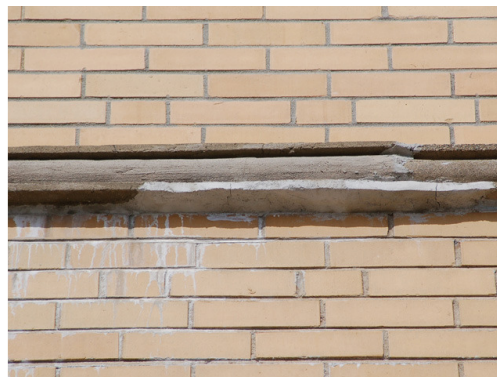
previously patched decorative cast stone

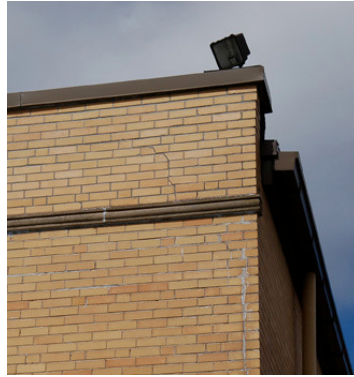
- Open or sealed mortar joints at brick walls and window sill units
- Cracked and sealed brick at the east and west corners of the auditorium
- Step cracking in the brick below window sills at the west elevation classroom windows

Cracked and sealed brick at southeast corner of auditorium

- Repoint mortar joints at exterior brick walls and chimneys and at cast stone elements including window sills
- Remove cracked brick and replace with matching brick

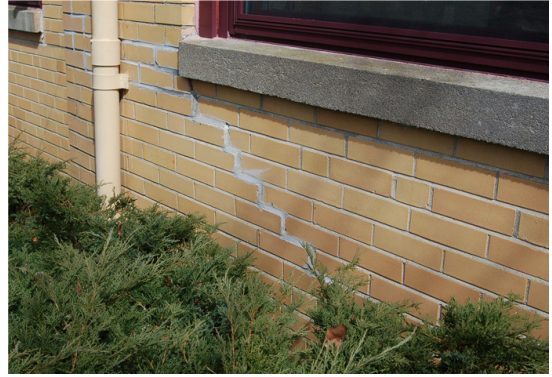
Step cracking below window sill, west elevation original building

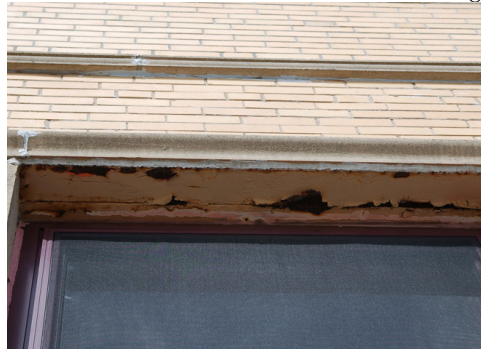
- Cracked and previously patched concrete at the top of the foundation wall throughout the 1959 portion of the building
- Rust and peeling paint at exposed steel window lintels at the auditorium and other single window openings at the north and east elevations

Rusted lintel at auditorium

- Remove deteriorated patches from top of concrete foundation wall and repatch. Chamfer top of foundation wall to shed water
- Scrape, prime and paint steel window lintels in place

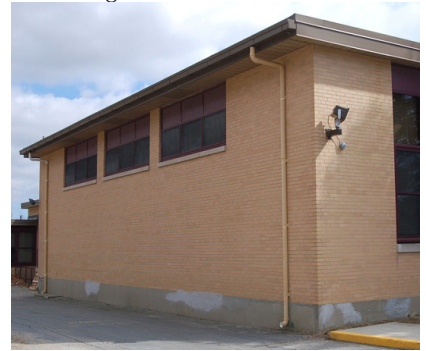
previously repaired areas at concrete foundation, 1959 building

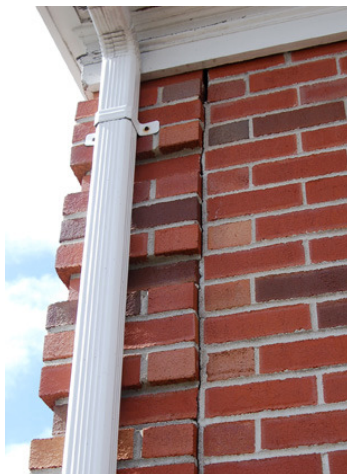
- Continuous cracks at the northeast and southeast corners of the 1988 additions. The brick quoins at these corners are not tied into the adjacent wall

Northeast corner crack.

- Remove mortar and install a control joint at the cracked corners of the 1988 addition

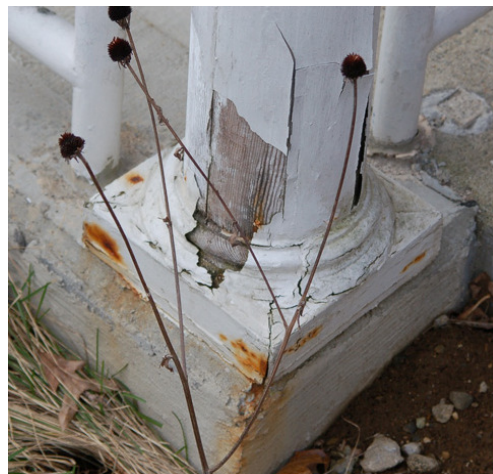
- Wood rot at the base of the entrance columns and checked and peeling paint at the remainder of the columns, the entrance door frame and sidelights
- Wood rot at soffit above lower level entrance at south wall of connector

Wood rot and peeling paint at base of entry post.

- Grout and patch cracks at concrete foundation and concrete block wall
- Replaced cracked/spalled brick with new brick
- Scrape steel lintels free of rust, prime and repaint. Repoint brick above lintels
- Remove paint from wood columns and entrance surround, perform consolidation and repair at rotted wood, prime and repaint.
- Replace or scrape, prime and paint rusted vent covers
- Replace missing gooseneck at west downspout
